Digital Vehicle Inspection

Gleniti Auto Services

Customer:		License:	
Vehicle:	Subaru Forrester	VIN:	
Inspection date:	5/27/2015	Odometer:	in: 249,034- km
Repair Order #:		Technician:	Harry Newmarch

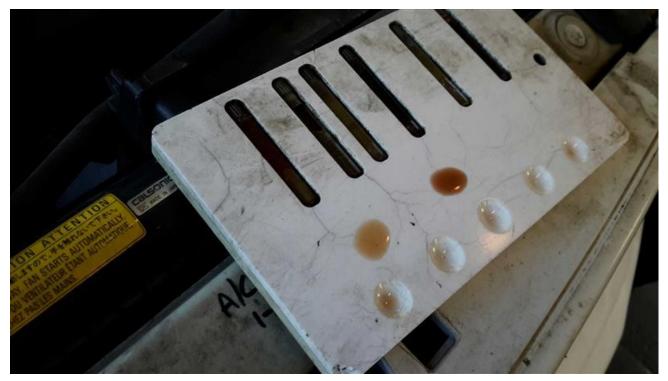
Requires Immediate Attention			
Fluids	Observation	Action	
Engine Oil	Dirty Overdue by 4000 km	Change Oil	
Transmission Fluid	VERY Dirty Image(s): http://tinyurl.com/opf8ey7 Right-hand mouse-click on link and select 'Open Link in New Tab'	Auto Transmission Flush Recommended

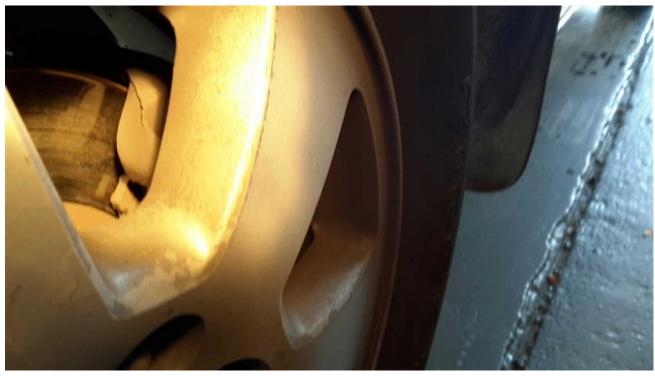
Bad		
Filters, Battery, Belts, and Radiator Hose	Observation	Action
Battery	Failed Load Test Cca 329 /470	Replace Battery
Fluids	Observation	Action
Power Steering Fluid	Dirty	Power Steering Flush Recommended
Tires, Brakes & Wheels	Observation	Action
Brakes: Front	<15% Image(s): http://tinyurl.com/po64ck3 Right-hand mouse-click on link and select 'Open Link in New Tab'	Replace Brake Pads

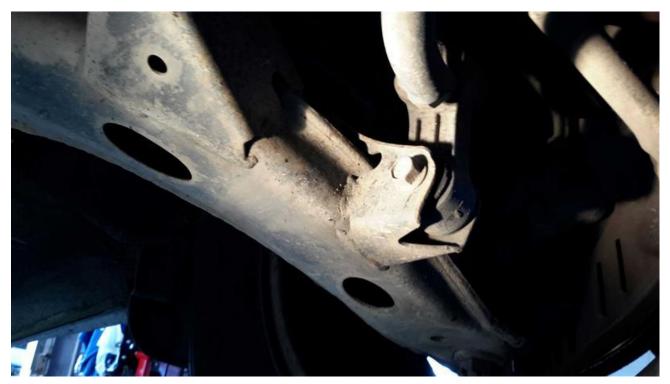
Maintenance		
Under Car	Observation	Action
Sway Bar Links/Bushings	Worn Image(s): http://tinyurl.com/ojf6gwe Right-hand mouse-click on link and select 'Open Link in New Tab'	Replace sway bar links
